FULL SCALE TESTS OF CONCRETE BRIDGE RAILS SUBJECTED
TO AUTOMOBILE IMPACTS

J. L. Beaton
Supervising Highway Engineer

Presented at the 35th Annual Meeting
of the Highway Research Board
Washington D. C., January 17-20, 1956

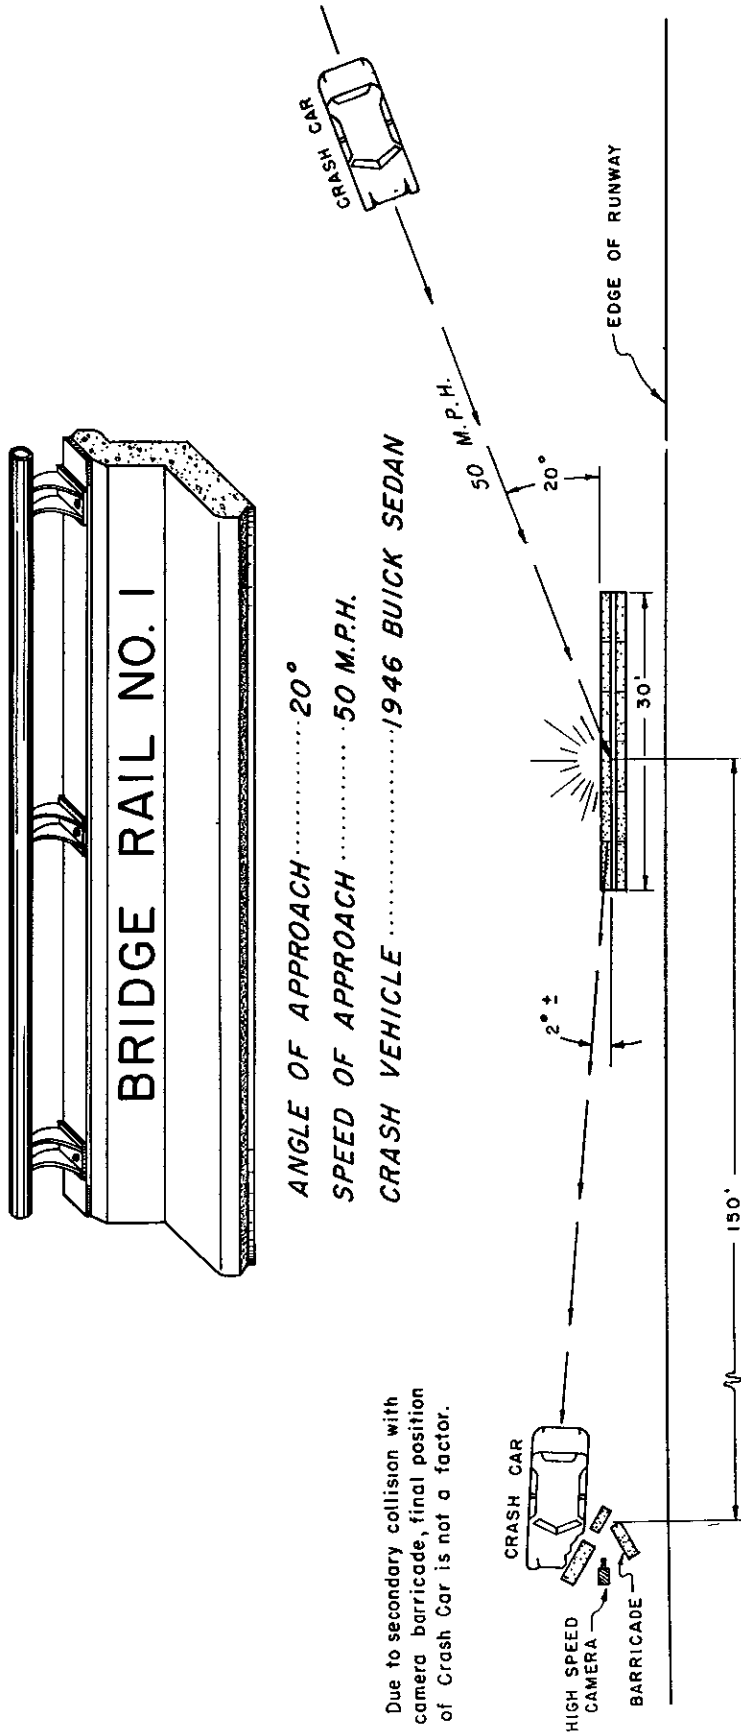
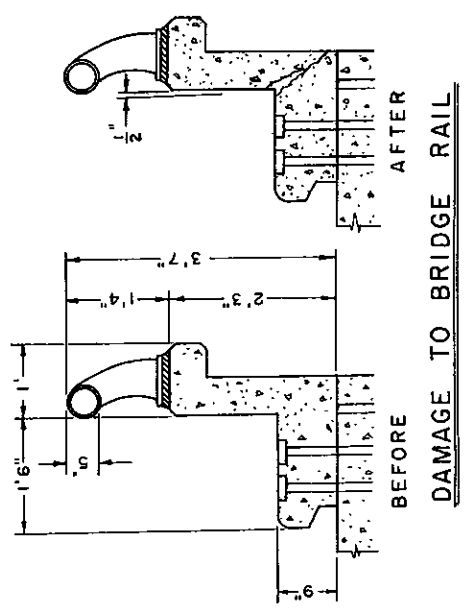
Figure 9

The crash vehicle used in this test was a 1946 Buick sedan which approached the test unit at an angle of 20 deg. and at a speed just prior to collision of 50 mph. Physical measurements of the red and green marks left from the contacts of the wheels with the test unit showed that the car mounted the 9 in. high curb with little or no sliding along the curb and then collided with and slid along the rail for 10 feet, then deflected off the rail and left the rail at about a 2 deg. exit angle. The car came to rest at a point about 150 feet from the point of collision, at which spot it collided with a camera barricade. Had it not been for this barricade, it is probable that the car would have travelled on for at least another 100 feet, swinging slowly in the direction of the damaged front wheel. The only damage to this railing and curb combination was to the 5 ft. section which bore the brunt of the collision. The concrete wall was pushed back out of plumb 1/2 in. and diagonal cracking occurred in the concrete running from the base of the concrete rail to the back heel of the curb block. This is shown in the "After" view titled "Damage to Bridge Rail" on Fig. 9.

The crash vehicle was deflected by the bridge rail at an angle of approximately 2°. The collision caused only a slight hesitation in the cars forward travel with minor tipping action noticeable as the car deflected along and then away from the bridge rail. The car mounted the 9" curb readily and then slid along the rail for 10' before leaving the Bridge Rail. It appeared that the pipe rail prevented excessive tipping of the car.

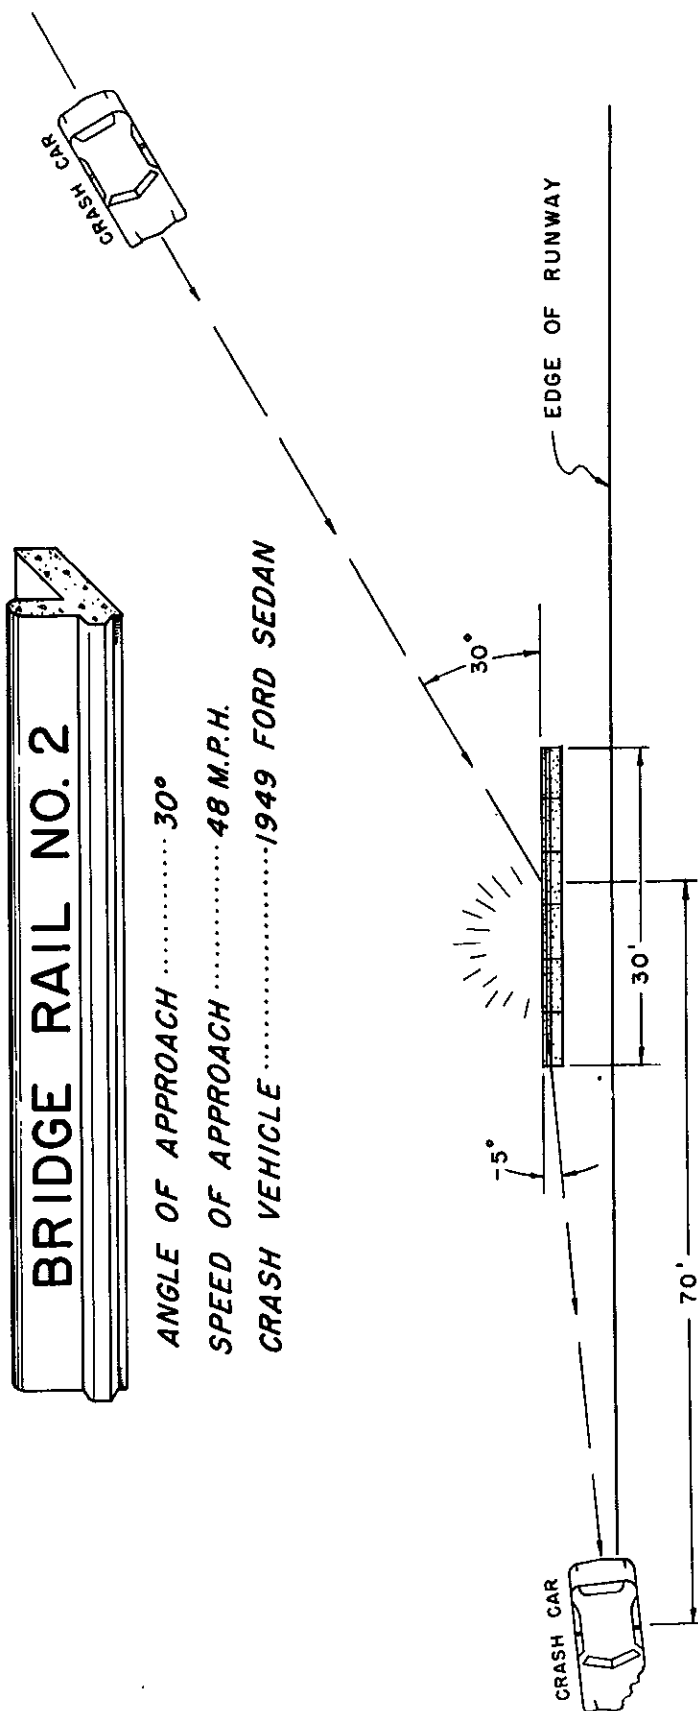
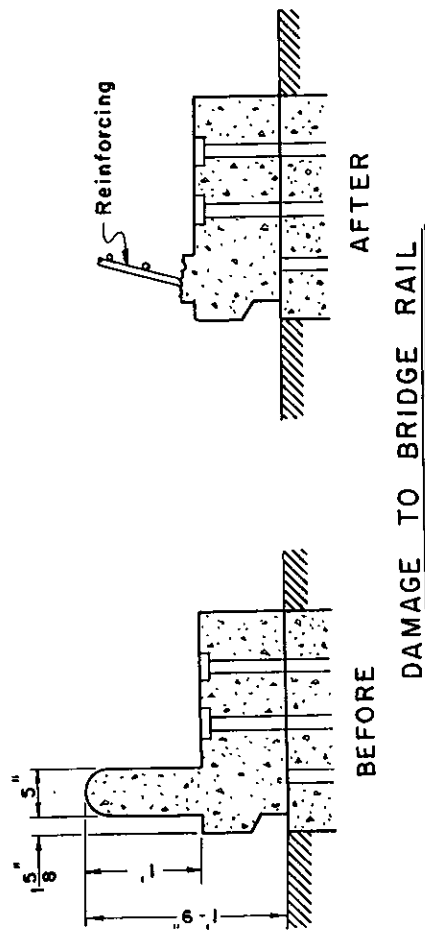
Figure 10

Analysis of the motion pictures shows that the most solid point of collision occurred when the front end of the crash car frame contacted the top edge of the rail. This caused an initial failure of the concrete apparently in direct punching shear, probably highly concentrated due to the unsupported edge of the railing slab. From this point of beginning the failure seemed to progress rapidly as further pressure was applied by the moving crash car.

To check the possibility of weak concrete, cores were taken from the broken concrete specimens of this railing. They indicated the concrete to have had a compressive strength of approximately 4800 lb. psi. Test cores of the concrete taken of all of the bridge rails indicated this to be about the average strength of the concrete in all test units. This also checks the test cylinder data taken during fabrication.

The crash vehicle broke out 9' of the bridge rail on the initial collision. This allowed the car to straddle the rail, and then continue on through the rail at an exit angle of approximately - 5°.

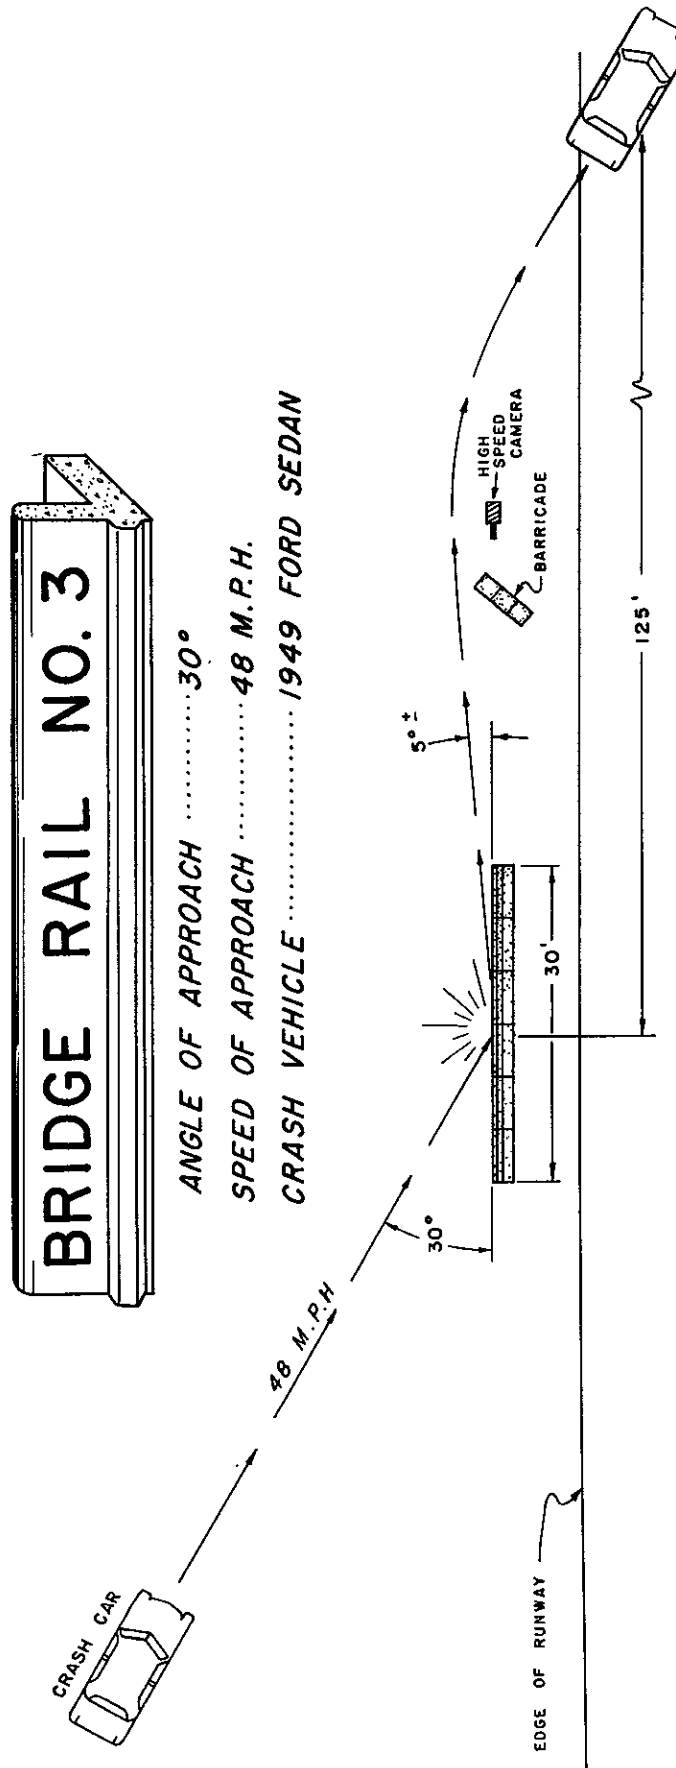
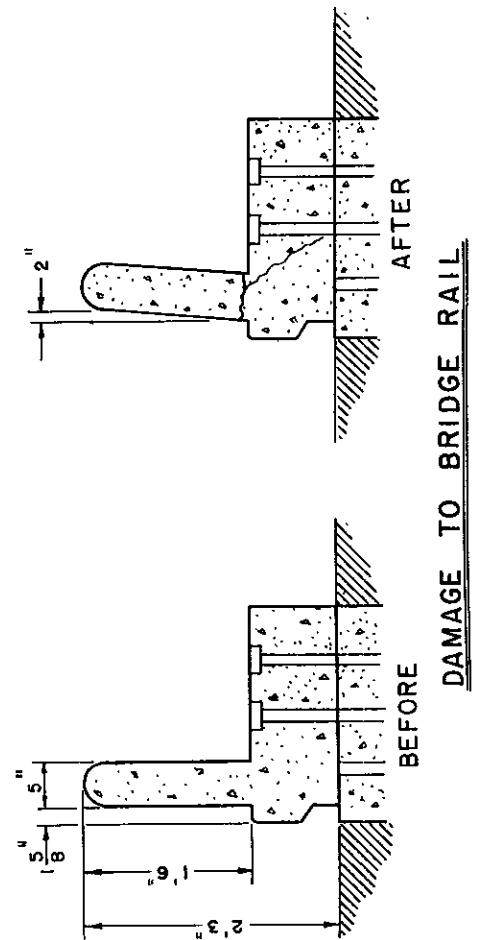
Figure 11

The crash car for the first test of this series was a 1949 2-door Ford sedan which collided with the test unit at an angle of 30 deg. and a speed of approach of 48 mph. The car glanced off the rail at an exit angle of about 5 deg. and came to rest about 125 feet from the point of collision. The car travelled in a straight line for about 70 feet after collision, then turned to the right. This turn was to the side of and caused by the front contact wheel, which had been badly damaged. This swing in the direction of the front damaged wheel was clearly shown only in this test because in the other four tests the crash car collided with a camera barricade before it had turned enough to be noticeable. It has been noted in other oblique collision tests (1) that this movement is typical.

The crash vehicle was deflected by the bridge rail at an angle of approximately 5°. The collision caused only a slight hesitation in the cars forward travel with minor tipping action noticeable as the car deflected away from the bridge rail.

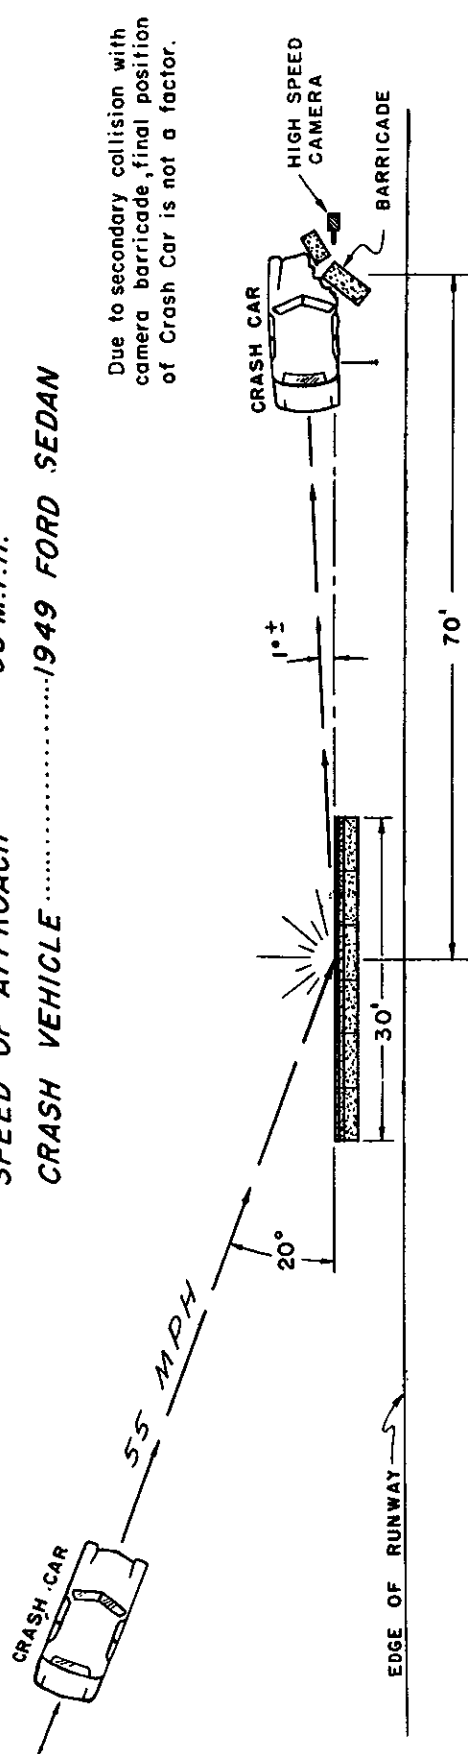
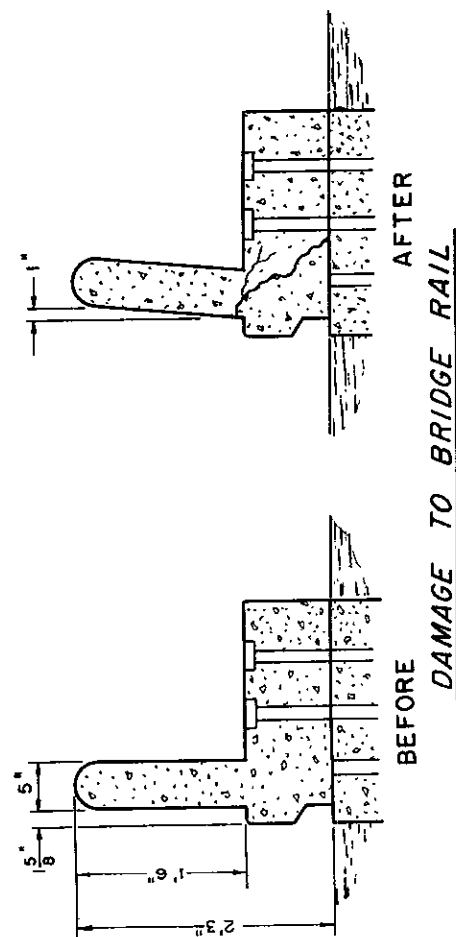
Due to secondary collision with camera barricade, final position of Crash Car is not a factor.

The crash vehicle was deflected by the bridge rail at an angle of approximately 1°. The collision caused only a slight hesitation in the cars forward travel with minor tipping action noticeable as the car deflected away from the bridge rail.

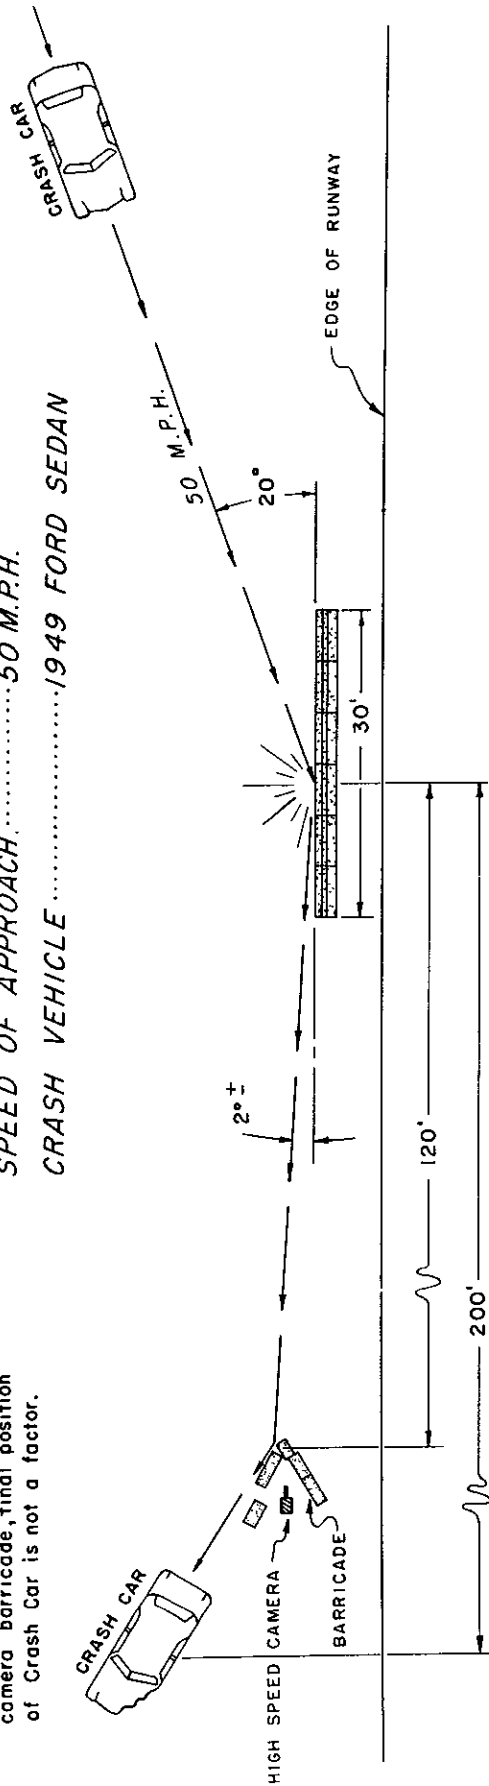
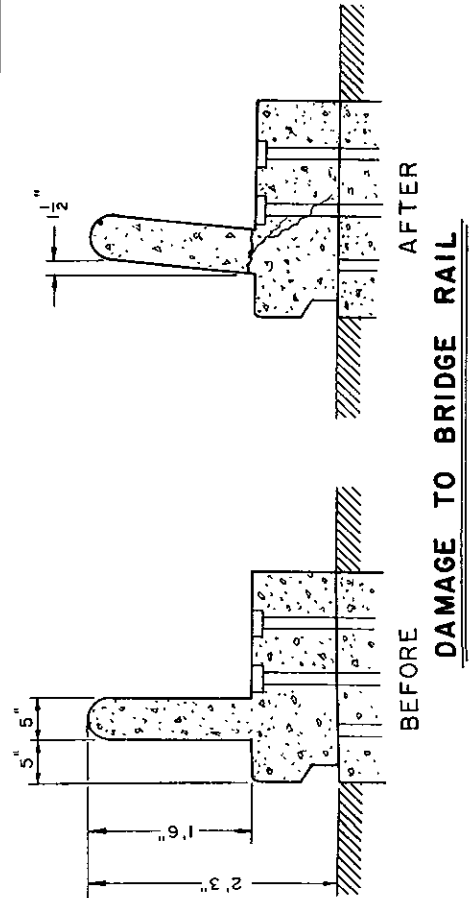
Figure 13

Due to secondary collision with camera barricade, final position of Crash Car is not a factor.

The crash vehicle was deflected by the bridge rail at an angle of approximately 2°. The collision caused only a slight hesitation in the cars forward travel with minor tipping action noticeable as the car deflected away from the bridge rail.

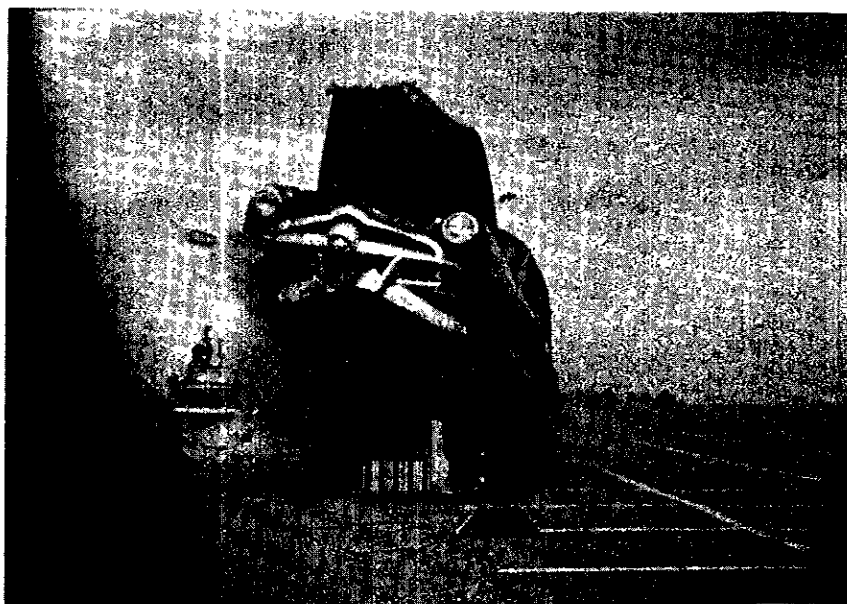
Figure 14. Test collision shortly after initial contact. Note recording movie camera in foreground.
